**National Highway
Traffic Safety
Administration**

Case Vehicle (A): 1999 Chevrolet
Type: Silverado, 4x4 extended cab pickup
Driver: 65-year-old male
CDC: 02-FDEW-2, 03-RZEW-2, 00-TDYO-3

Vehicle (B): 1996 Chrysler
Type: Concorde, 4-door sedan
Driver: 79-year-old male
CDC: 11-LYEW-4, 09-LZEW-2

GENERAL VEHICLE DAMAGE AND ESTIMATED CRASH SEVERITIES

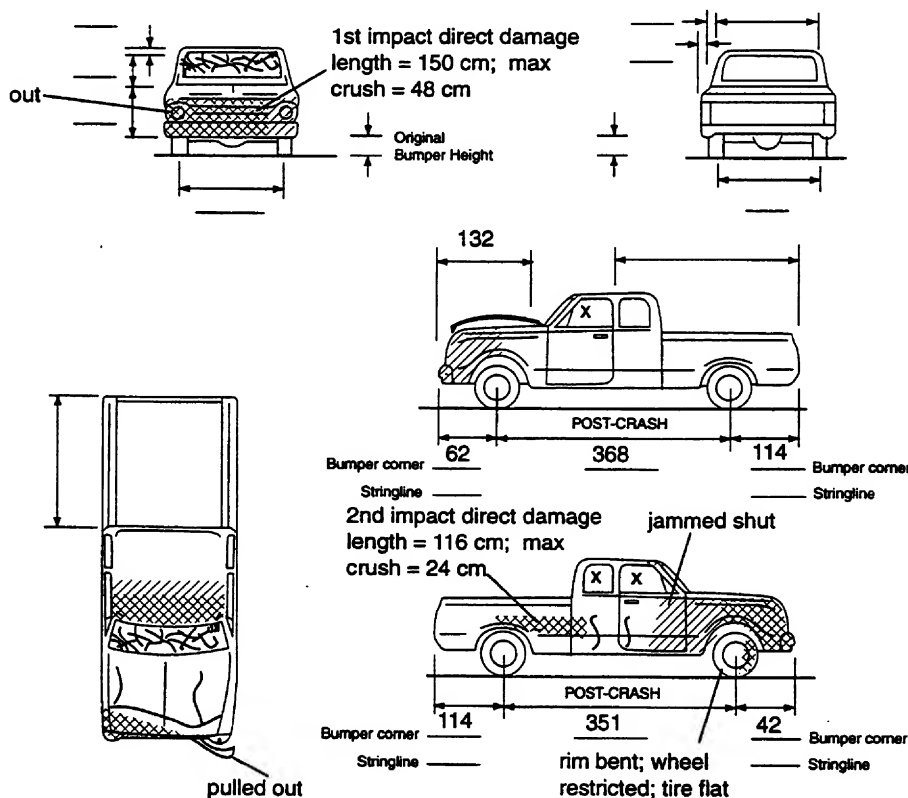
VEHICLE DAMAGE

Specific Impact No.	Location of Direct Damage	Location of Field L
1	Begins @ front bumper corner	B.C. to B.C.
2	Begins +17cm from rear axle	Begins +17cm from rear axle

Specific Impact Number	Plane of Impact C-Measur.	Direct Damage		Field L	C ₁	C ₂	C ₃	C ₄	C ₅	C ₆	±D
		Length (DDL)	Max Crush								
1	Bumper	150	C6	151	50	39	37	64	75	97	+15
	- String line adj.				-31	-31	-31	-31	-31	-31	
	- Free space				-18	-7	-2	-2	-7	-18	
					0	1	4	31	37	48	
1	1	150	048	151	001	001	004	031	037	048	+015
13	14	15 16 17	18 19 20	21 22 23	24 25 26	27 28 29	30 31 32	33 34 35	36 37 38	39 40 41	42 43 44 45
2	Above sill	106	C3	116	21	24	25	24	18	11	-70
	- String line adj.				-1	-1	-1	-1	-1	-1	
					20	23	24	23	17	10	
	- taper				-5	-2	-0	0	0	0	
					15	21	24	23	17	10	
2	4	106	024	116	15	21	24	23	17	10	-070

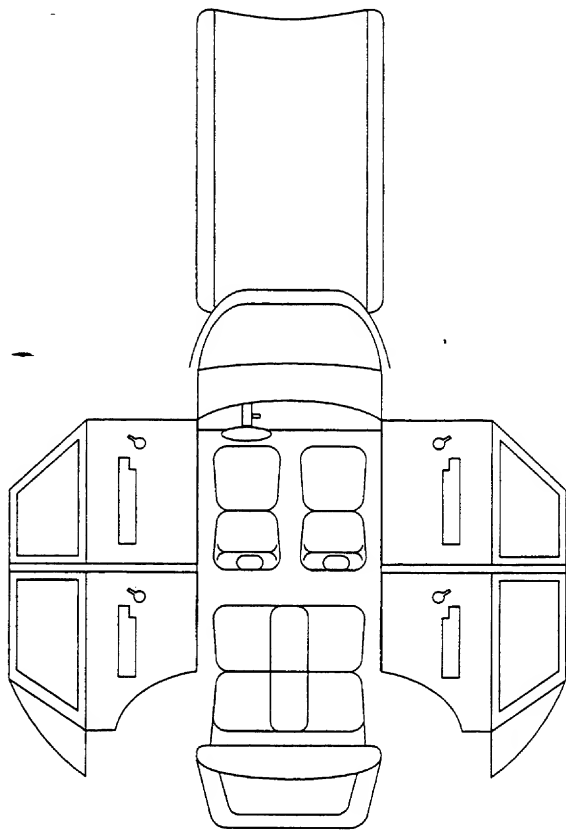
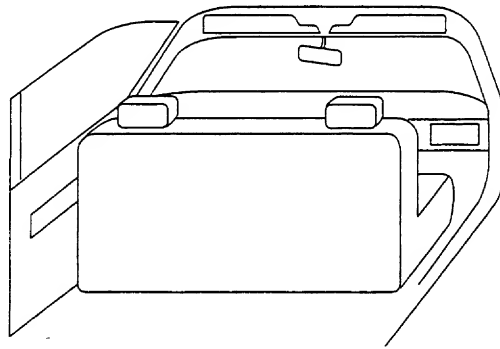
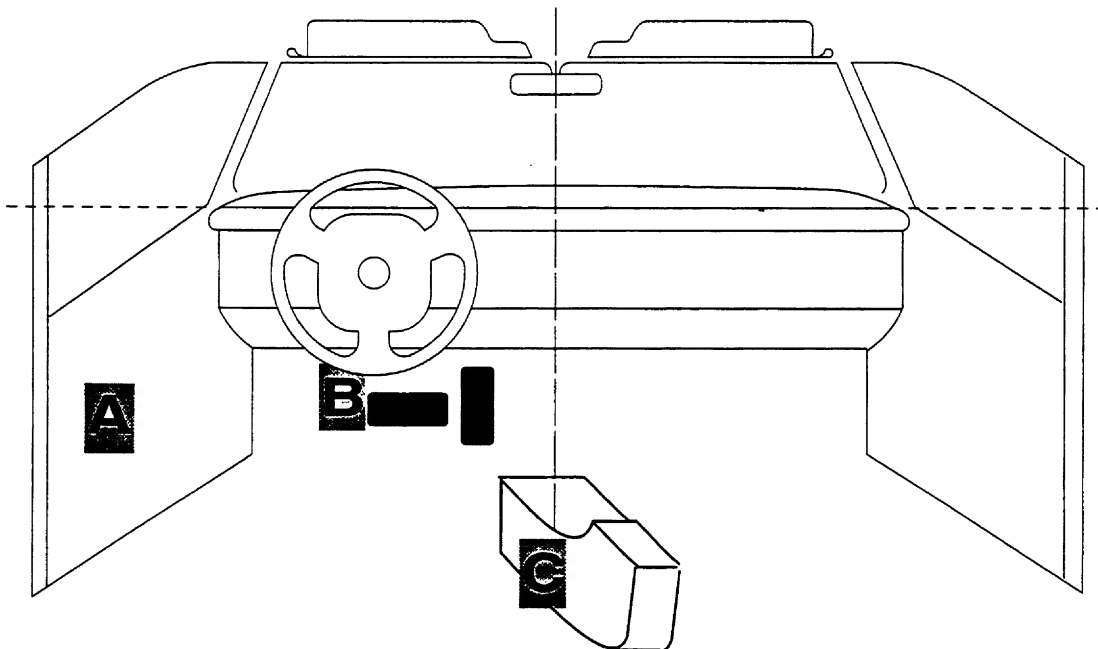
OCCUPANT CONTACT WORKSHEET

Contact	Interior Component Contacted	Occupant No. if Known	Body Region if Known	Supporting Physical Evidence	Confidence Level of Contact Point
A	Interior door	1	hip	large scuff-mark	1
B	underside of column	1	Knee	scuff-mark	1
C	ctr. Console	1	hip	small scuff-mark	2
D	Roof	1	head	blood (rust?) smear	3
E					
F					
G					
H					
I					
J
